EXERCISE DESERT ROCK LAS VEGAS NV

EXERCISE DESERT ROCK V. JANUARY-JUNE 1953. VOLUME I. OPERATIONS--ETC(U)

Exercise Desert Rock V

Volume I - Operations

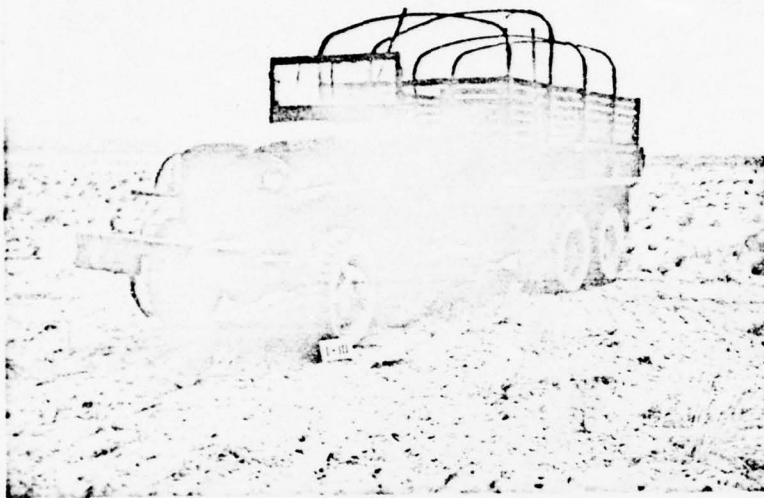
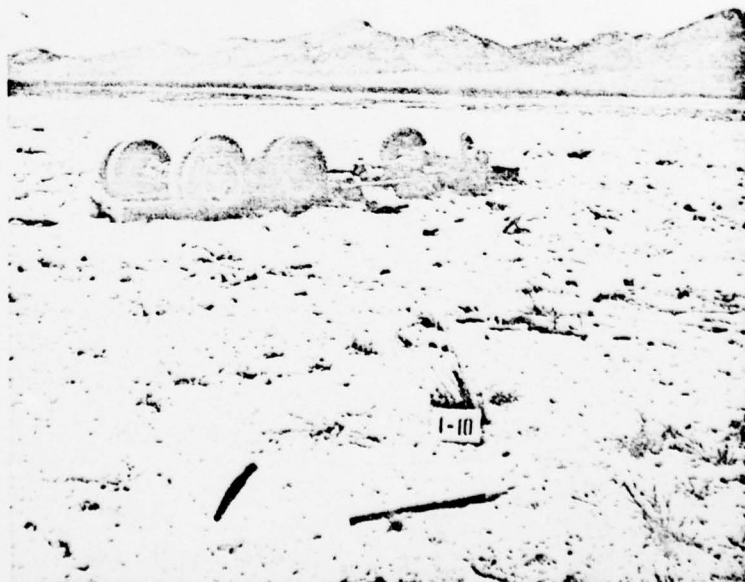
Truck, 2½ ton, 380  
yards from GZ.

Thrown approximate-  
ly 150 feet and de-  
molished. Wreckage  
in pieces.

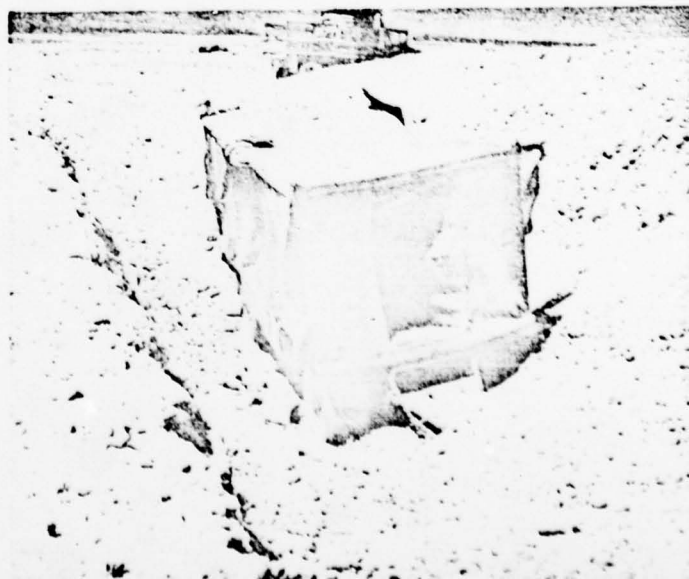
Van, Radar Set,  
SP-1M, dug in,  
side to blast 625  
yards from GZ.

Unmoved. All sides and  
top blasted in. Damaged  
beyond repair.

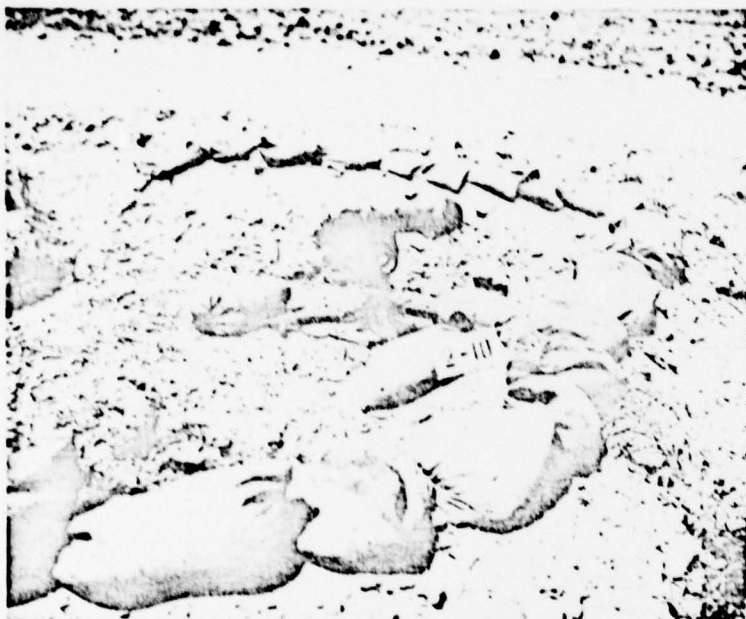
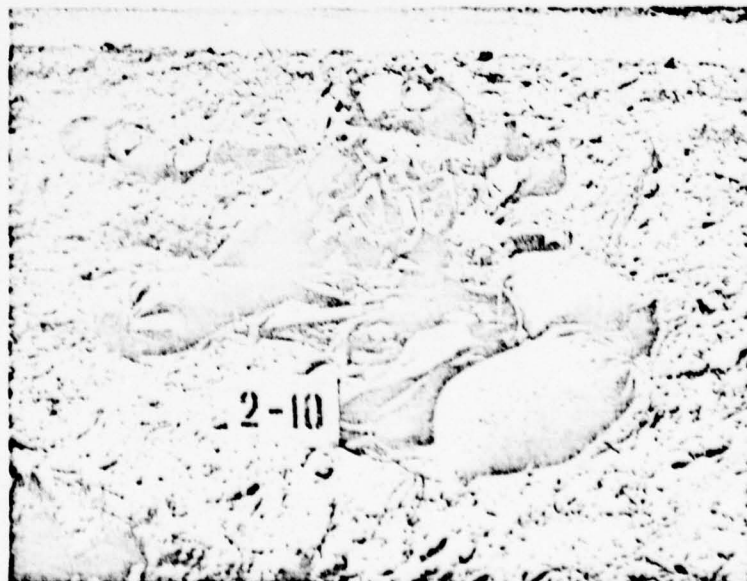
Machine Gun, Cal 30  
M1917A1, dug in at  
1015 yards from GZ.

Gun swung 180 degrees  
and muzzle depressed  
to ground. Apparently  
undamaged.

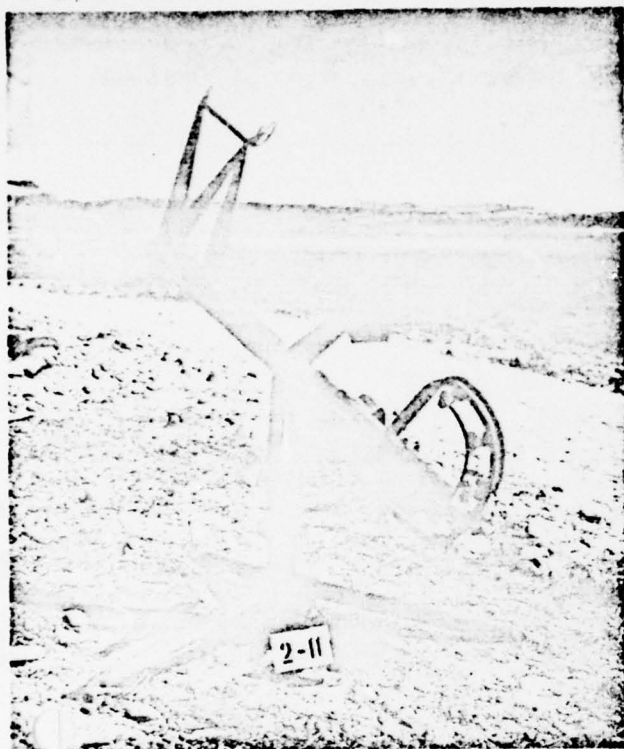
Machine Gun, Cal. 50, AA,  
ground level 1025 yards from  
GZ.

Thrown 60 feet. Shield  
blown off. Sight twisted  
out of shape.

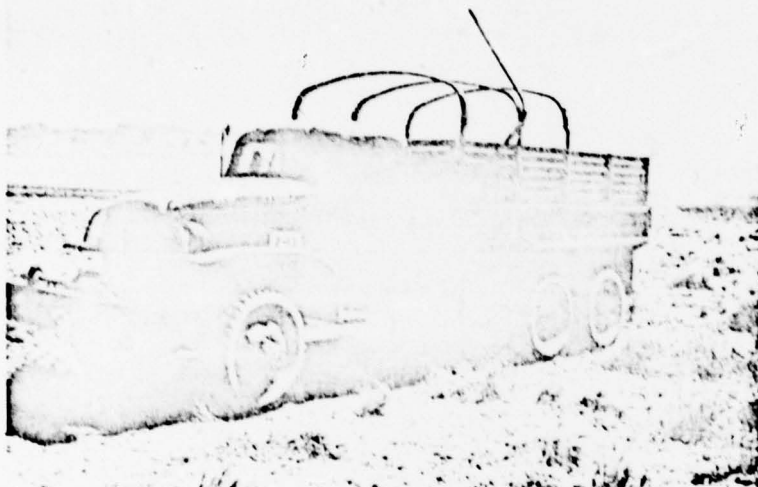
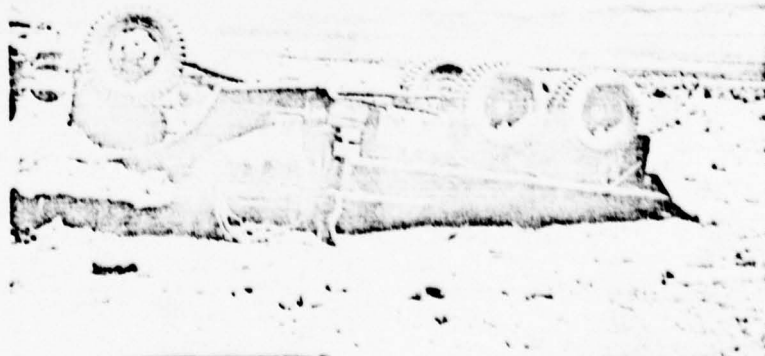
Truck, 2½ ton, 1025  
yards from GZ.

Thrown 45 feet, over-  
turned. Severely da-  
maged.

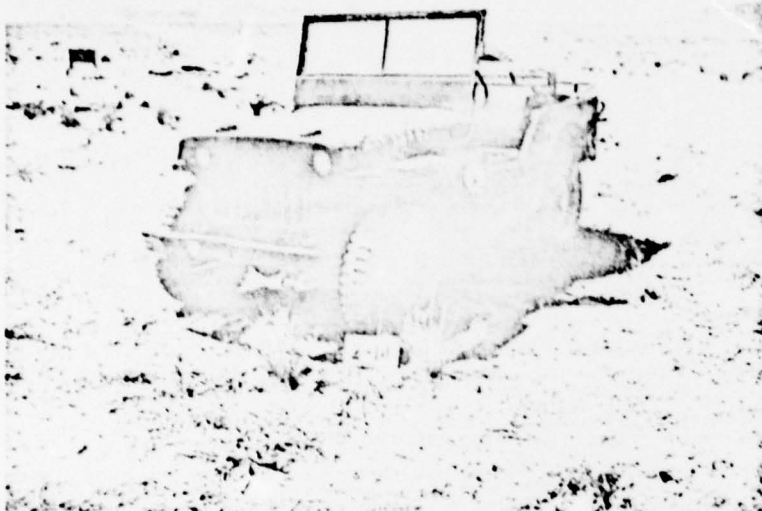
Truck,  $\frac{1}{4}$  ton 1025 yards  
from GZ.

Thrown 40 feet and  
overturned. Severely  
damaged.

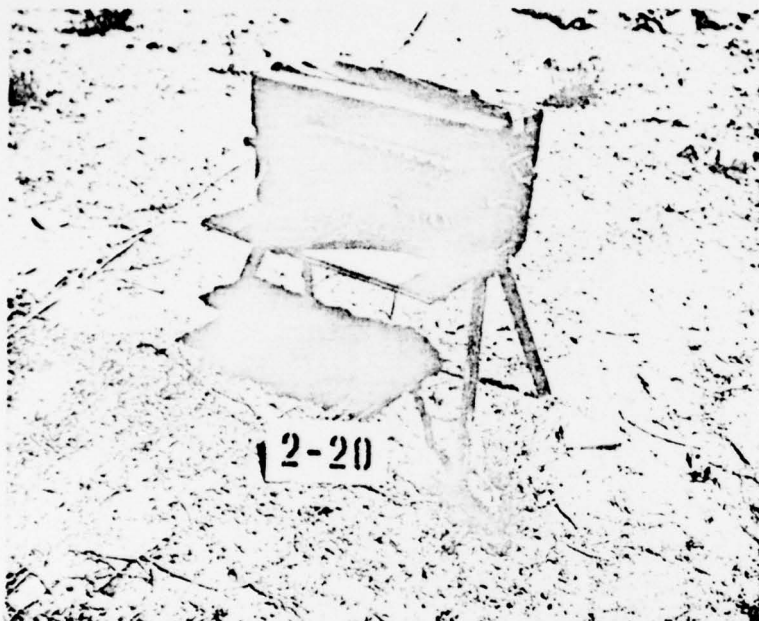
Switchboard, ED-72,  
standing in open  
1050 yards from GZ.

Thrown 30 feet and  
damaged beyond re-  
pair.

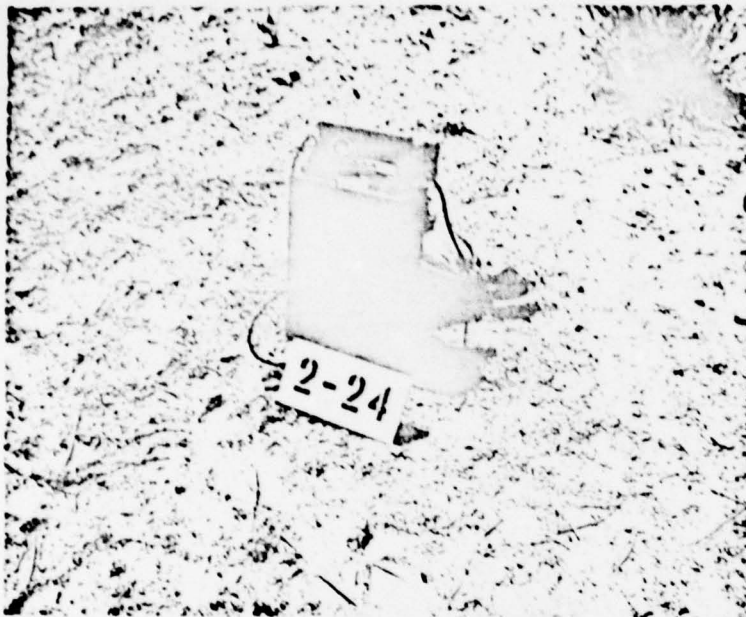
Radio, SCR-300,  
standing, propped  
by sandbag 1060  
yards from GZ.

Thrown 90 feet. Se-  
verely damaged.

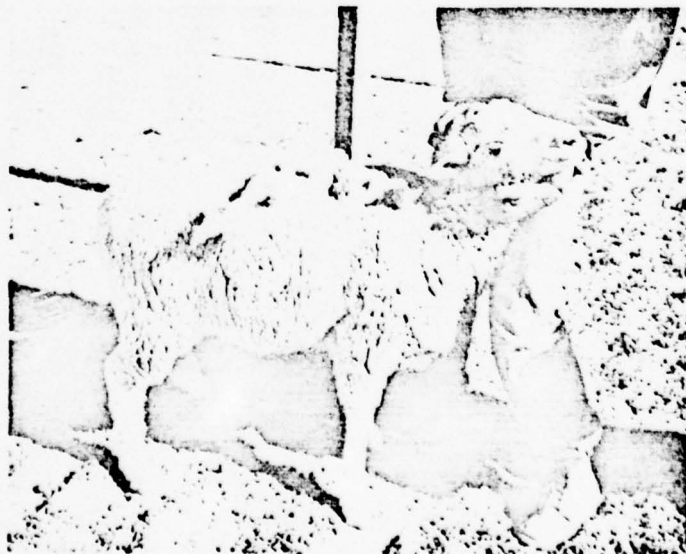
1,500 yards - 6 feet trench. This sheep initially suffered no visible effects from the detonation. Epilation commenced 10 May and can be seen in the picture.

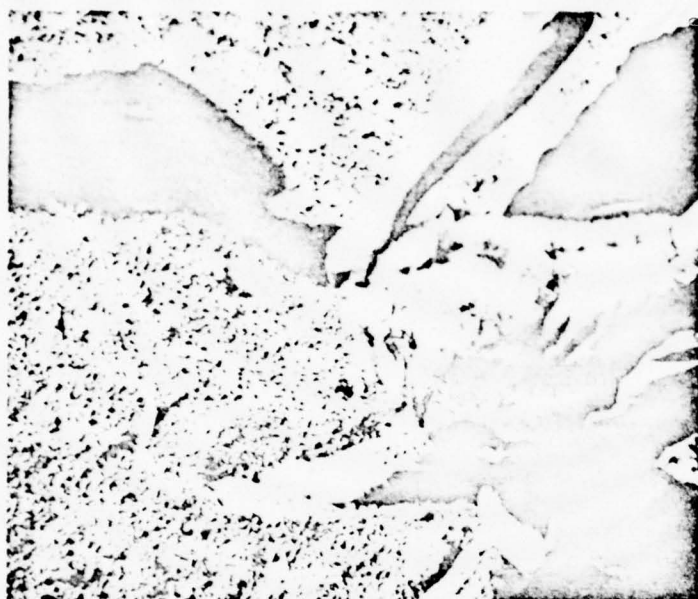
At 2000 yards the sheep at position C-9 had second degree burns on the ears and extensive wool burns covering 1/2 the body area. This animal suffered no other ill effects until epilation, i.e., loss of hair, appeared 8 May. This animal has as yet shown no inappetence and it is considered to have a better than average chance to effect a recovery. The dose of radiation this animal received was 253 r. The sheep at position C-8 had third degree burns on the face and moderate wool burns.

C-9, 2000 yards. This sheep initially suffered second degree burns on the face and extensive wool burns. Epilation commenced 8 May which is shown by the denuded area on the head.

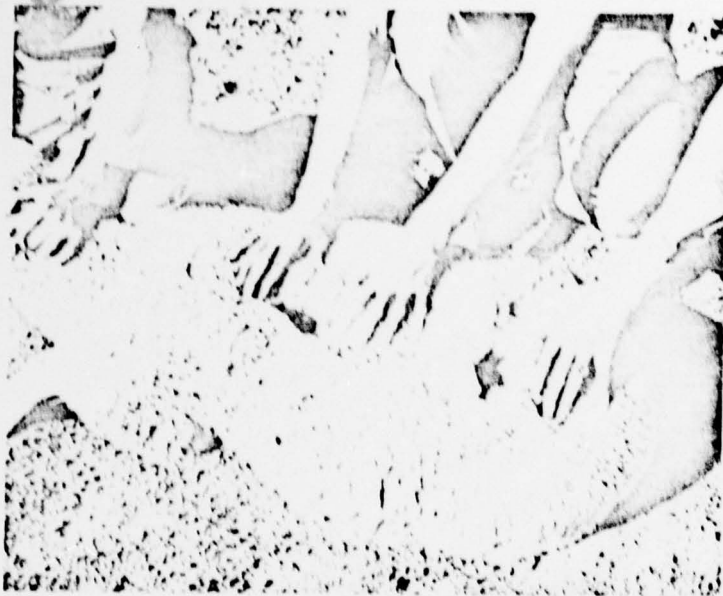
1700 yards - 6 feet trench.  
This sheep initially suffered no visible effects from the detonation. Epilation commenced 3 May. Note the two defined areas.

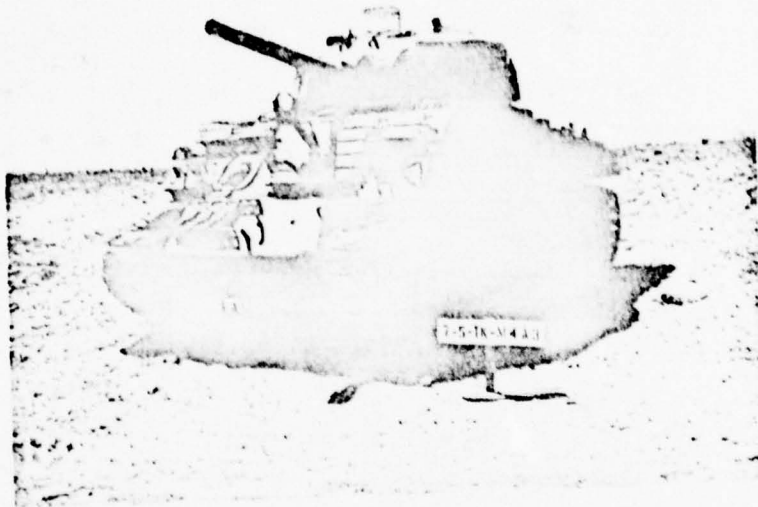
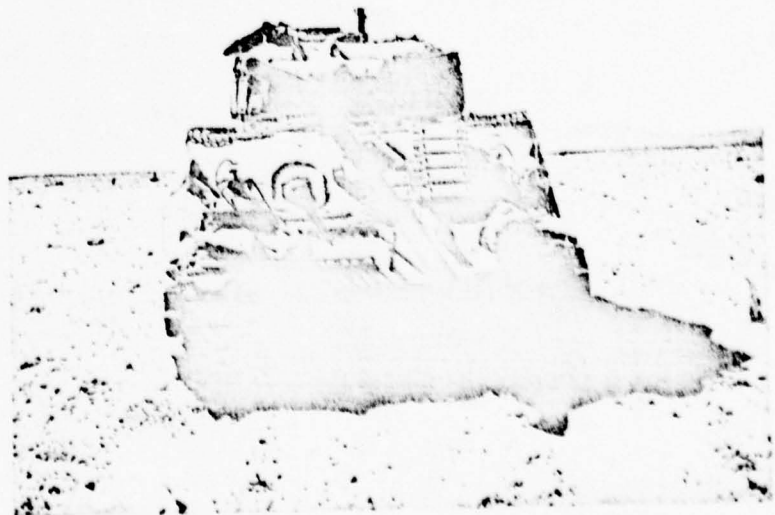
Tank, Medium, M4A3,  
facing GZ at 500  
yards.

Destroyed beyond re-  
pair. Turret blown  
loose but still on  
top of tank. Vehicle  
was moved back about  
20 feet and badly  
burned.

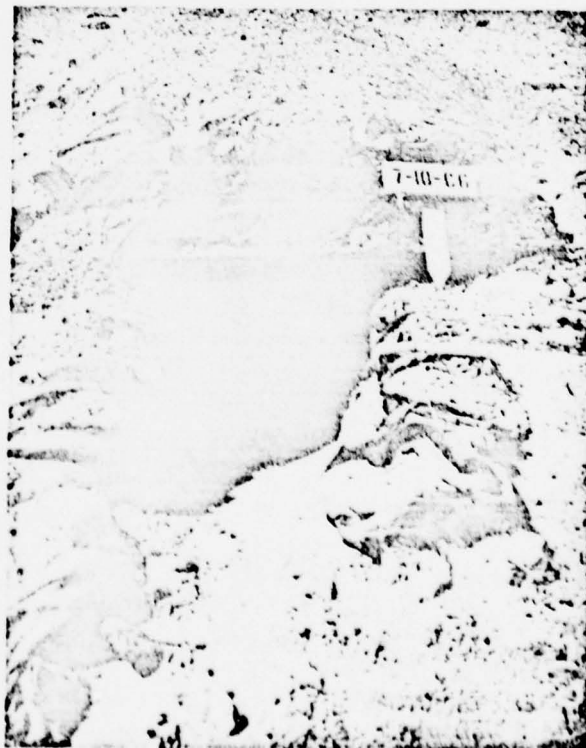
C-6 Bunker at 1000  
yards from GZ.

All sandbags destroyed and rear  
wall caved in.

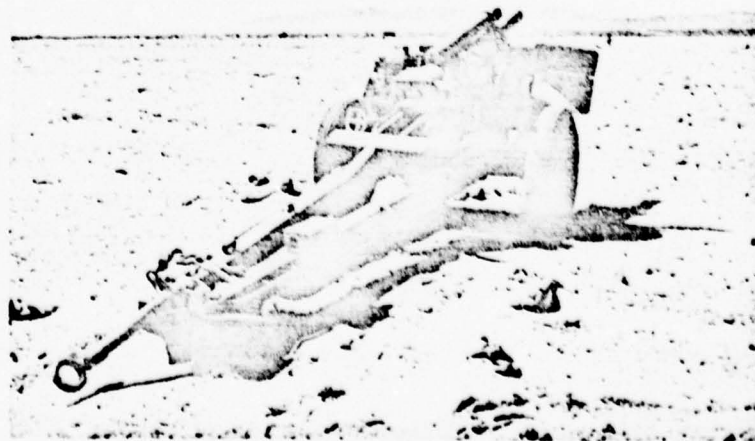
105 MM Howitzer,  
M2A2, facing away  
from GZ at 1000  
yards.

Howitzer moved away  
from GZ 50 feet.  
Glass in sights and  
the tires scorched.  
Entire weapon sand-  
blasted.

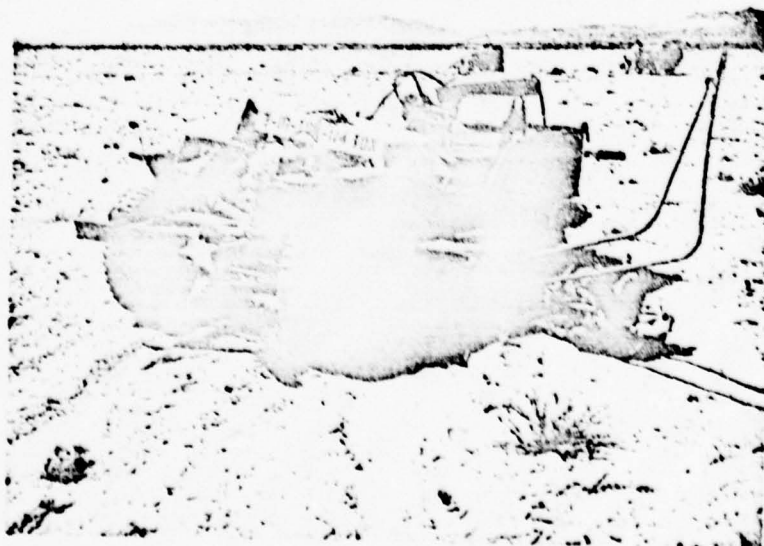
Truck,  $\frac{1}{2}$  ton, 4 x 4,  
M-38 facing GZ at  
1000 yards.

Destroyed beyond re-  
pair. Moved backward  
100 feet.

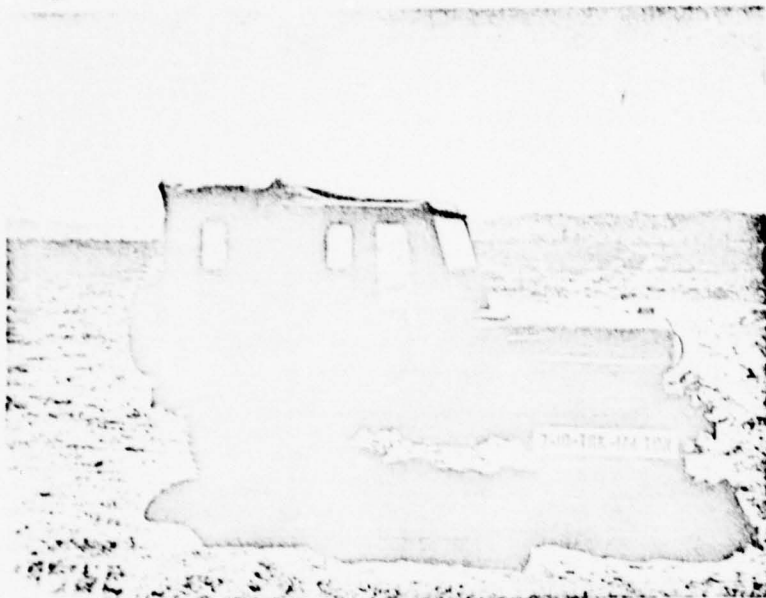
Truck,  $\frac{1}{2}$  ton, 4 x 4,  
M-38 facing GZ at  
1000 yards.

Completely destroyed.

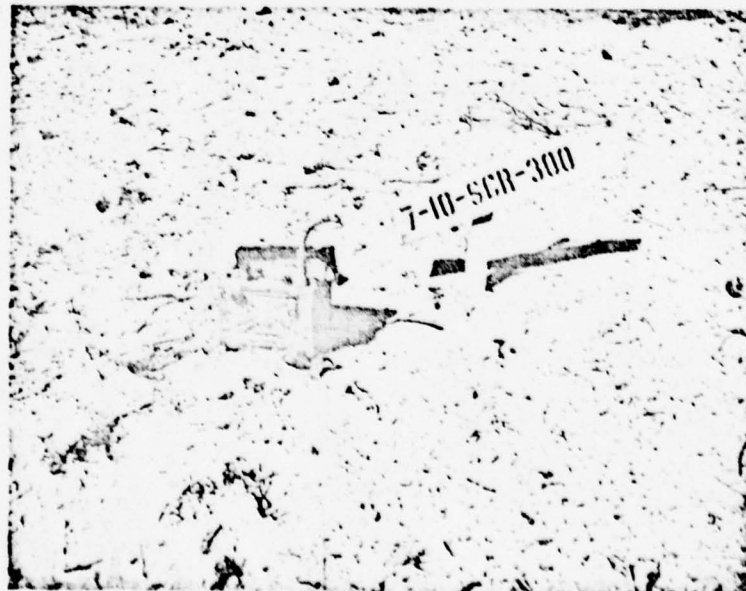
Radio, SCR-300,  
placed flat on  
ground 1000 yards  
from GZ.

Battery container  
blown off. Cover  
hinge blown off.  
Scorched extensively  
inside of case.

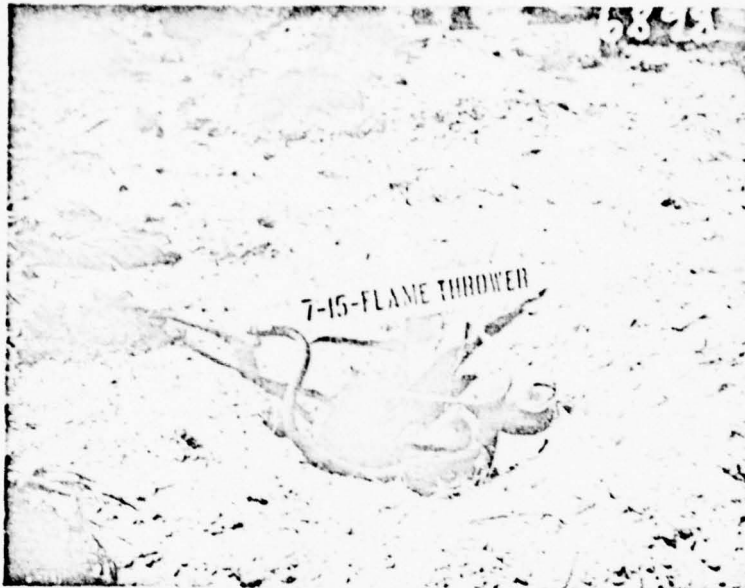
Portable flamethrower,  
M2A1, in small defi-  
lade with back to GZ,  
1500 yards from GZ.

Band holding tanks  
together is broken.  
Hose and harness  
badly scorched.

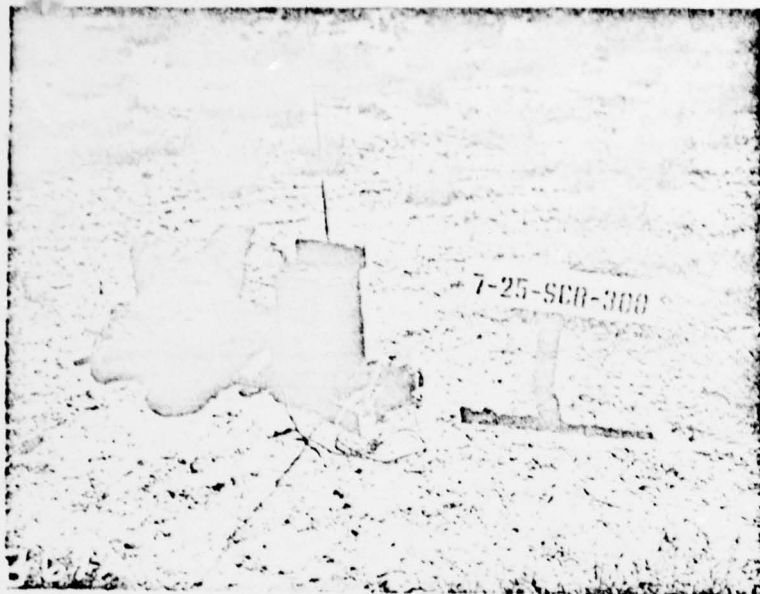
Radio, SCR-300, standing upright beside dummy soldier 2500 yards from GZ.

Blown completely apart. All tubes and most of the interior wiring torn out.

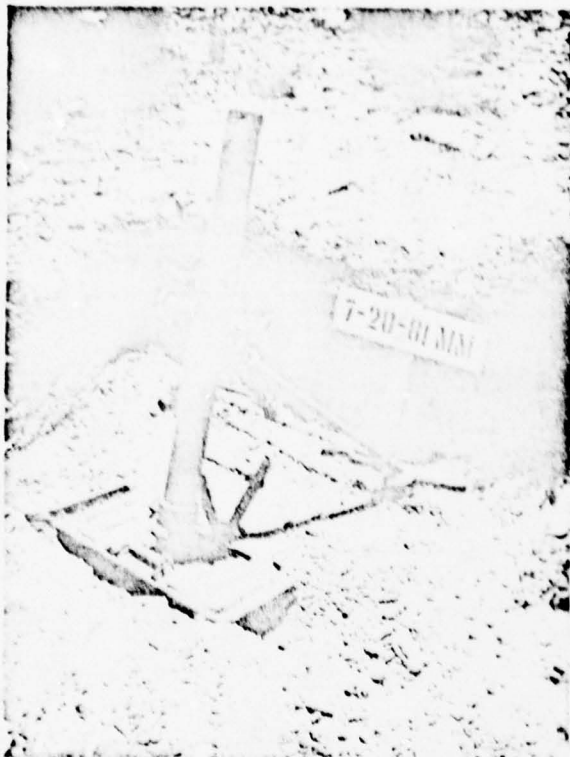
81 MM Mortar, (T-106), dug in  
facing away from GZ at 2000  
yards.

Undamaged.

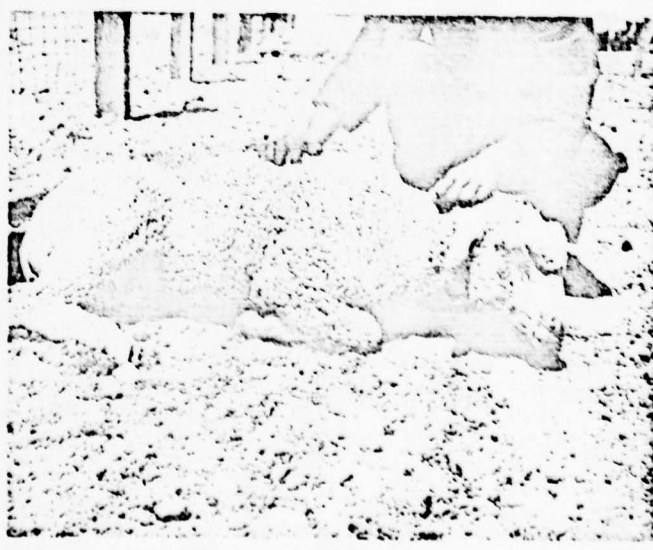
C-7 1000 yards. 3rd degree burns of face and ears. Extensive wool burns. Destroyed 21 May to prevent suffering. Received dosage of 71 r.

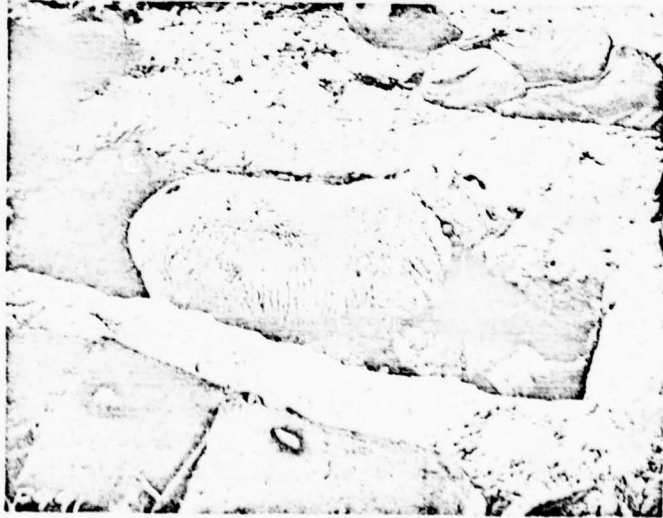
C-8 1500 yards. No vi-  
sible effects. Dosimeter  
reading lost.

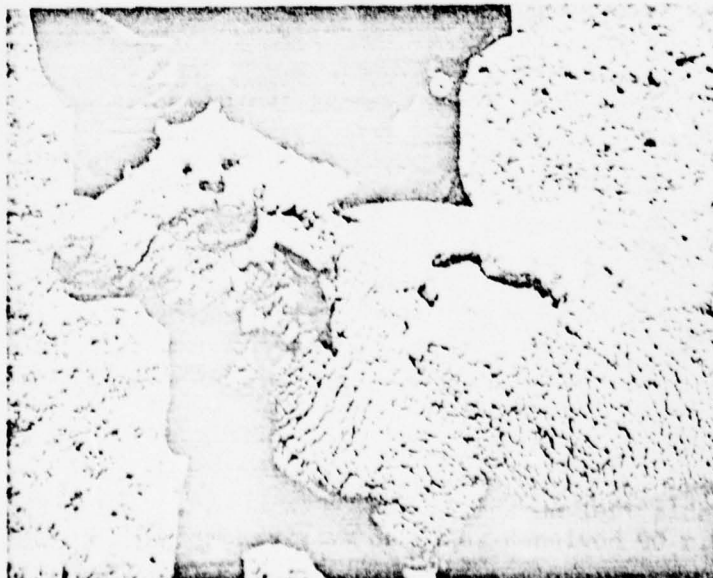
C-9 2000 yards. 2nd degree burns on face and ears. Extensive wool burns on back. Received 80 r. Destroyed 21 May to prevent suffering.

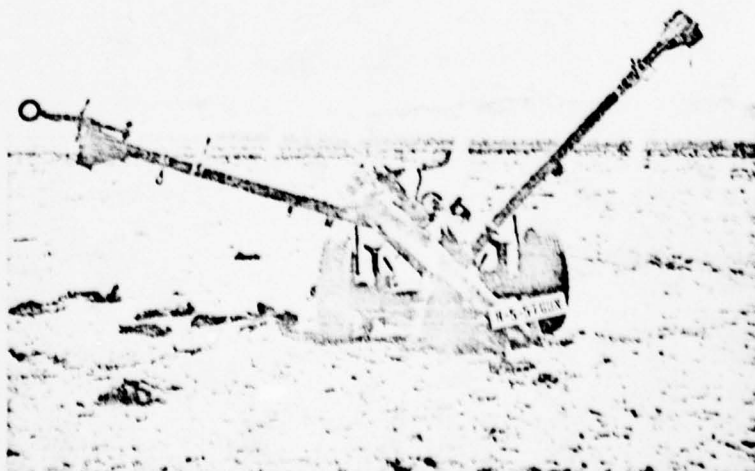
57 mm Gun, M1, facing  
away from GZ at 500  
yards.

Weapon moved 65 feet.  
Right trail and wheel  
bent. Shields blown  
off. Tube embedded  
about 4 feet in ground  
and is probably bent.

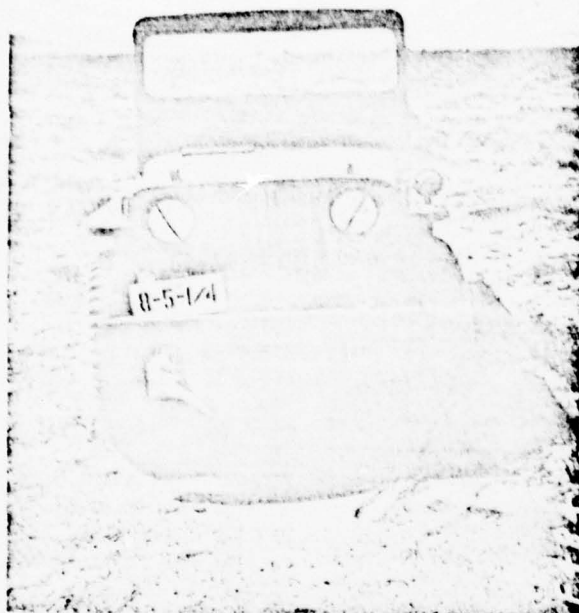
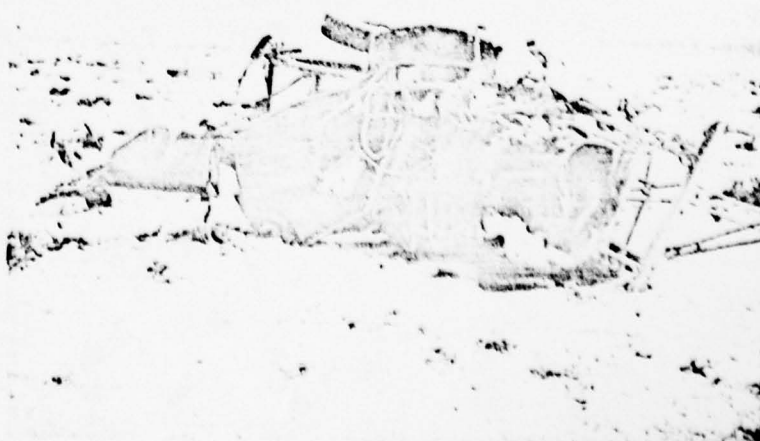
Truck,  $\frac{1}{2}$  ton 4 x 4, M-38  
facing 10 degrees right of  
GZ at 500 yards.

Completely destroyed.  
Major part moved  
150 feet. Parts of ve-  
hicle found at 800  
yard line.

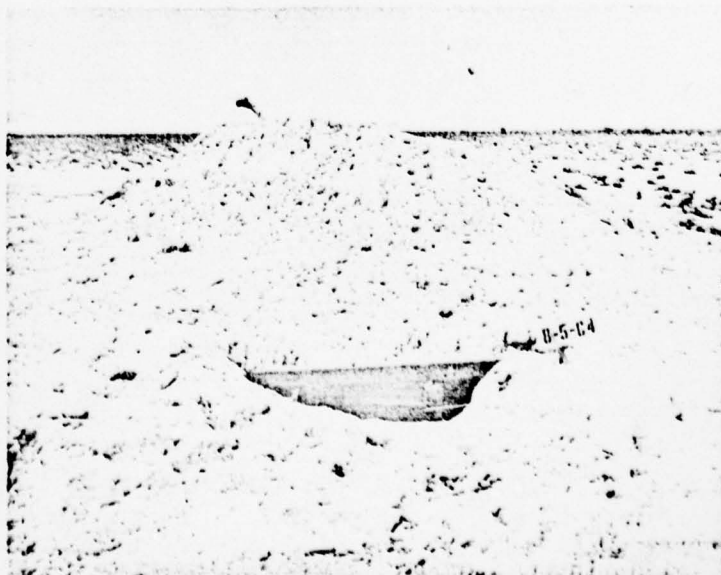
C-4 bunker 500 yards  
south and slightly  
east of GZ. Entrance  
is facing north.

All sandbags destroyed  
and scattered. Header  
over entrance gave way.  
Entrance filled with  
sand.

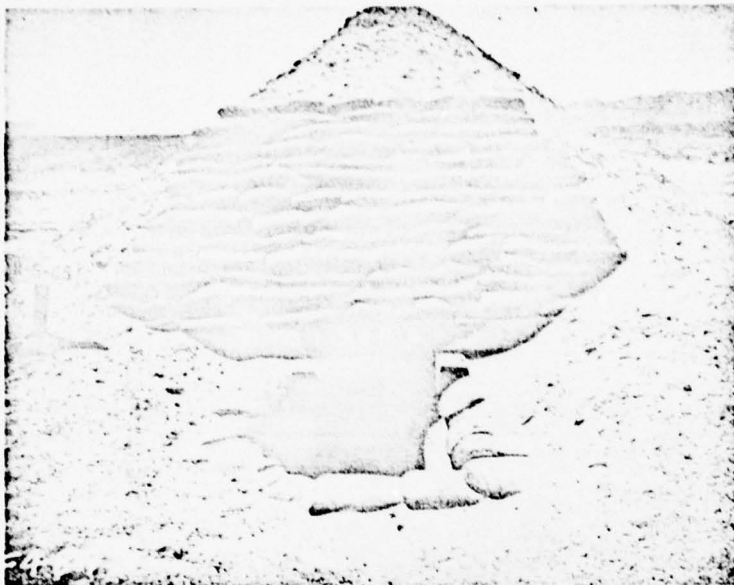
C-5 bunker 500 yards  
south and slightly  
east of GZ. Entrance  
is facing north.

Completely destroyed.

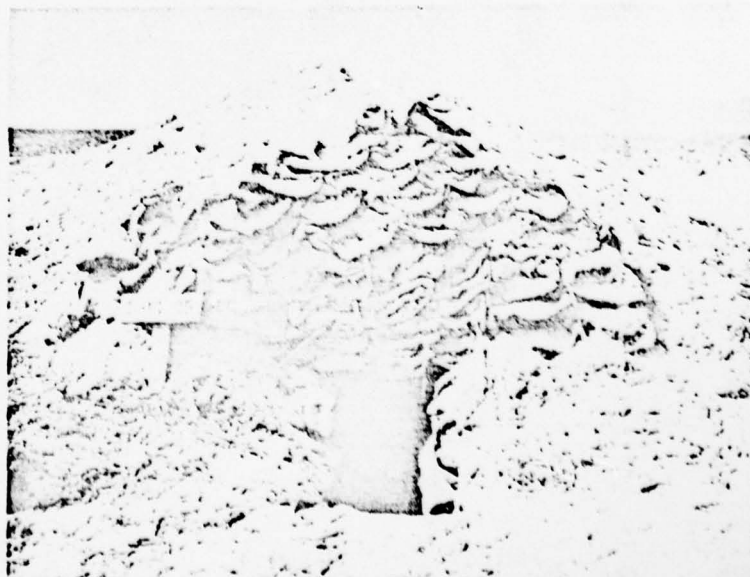
AFTER

All sandbags are destroyed. Fill from sandbags fell into bunker entrance.

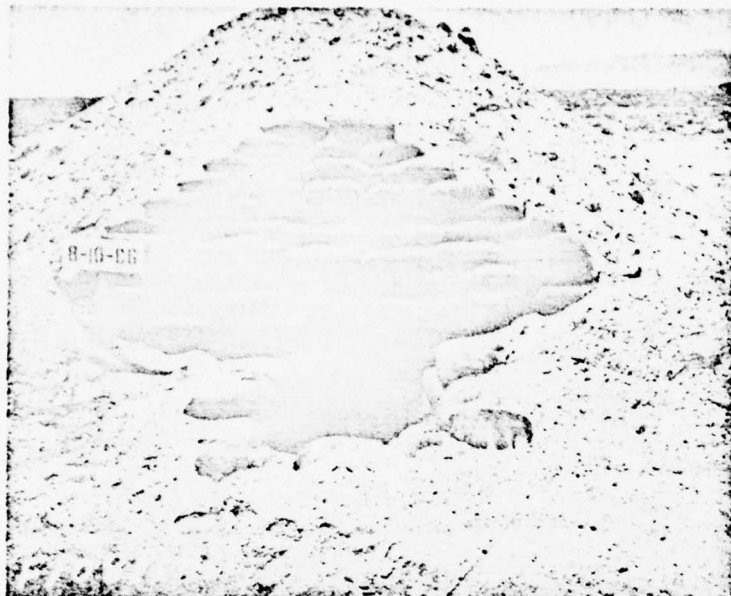
BEFORE

C-6 bunker 1000 yards  
south and slightly  
east of GZ. Entrance  
is facing north.

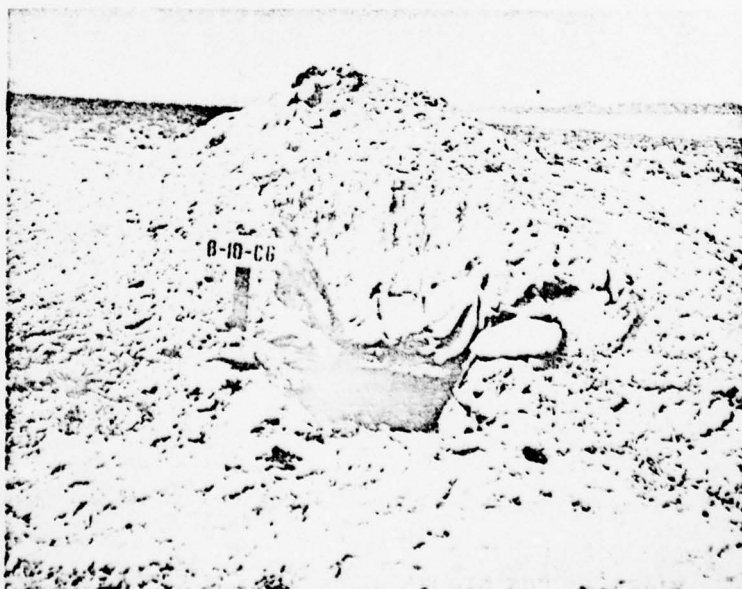
AFTER

All sandbags destroyed.  
Fill from sandbags fell  
into bunker entrance.

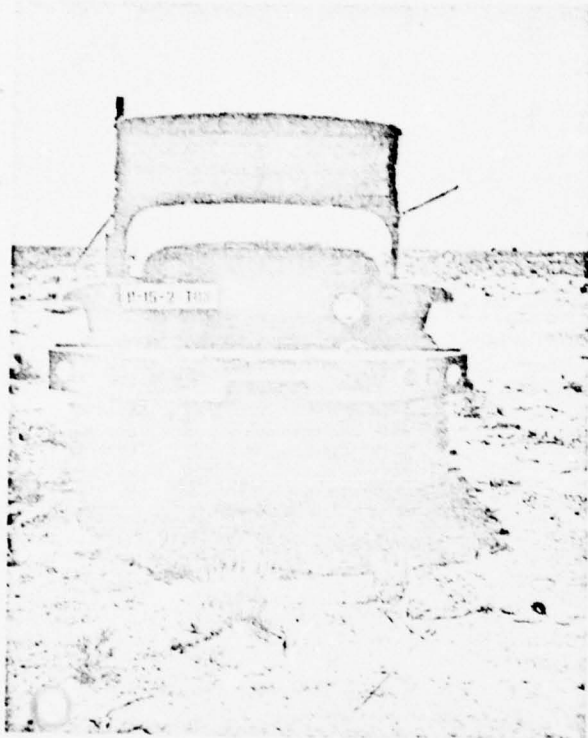
BEFORE

Truck 2 1/2 ton 6 x 6, M-135  
facing GZ at 1500 yards.

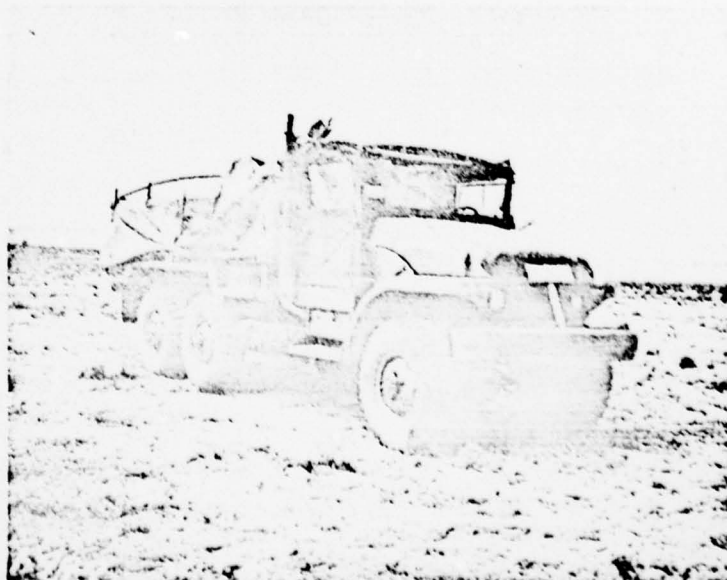
AFTER

All glass blown out and  
canvas and bow des-  
troyed. Paint on front  
burned.

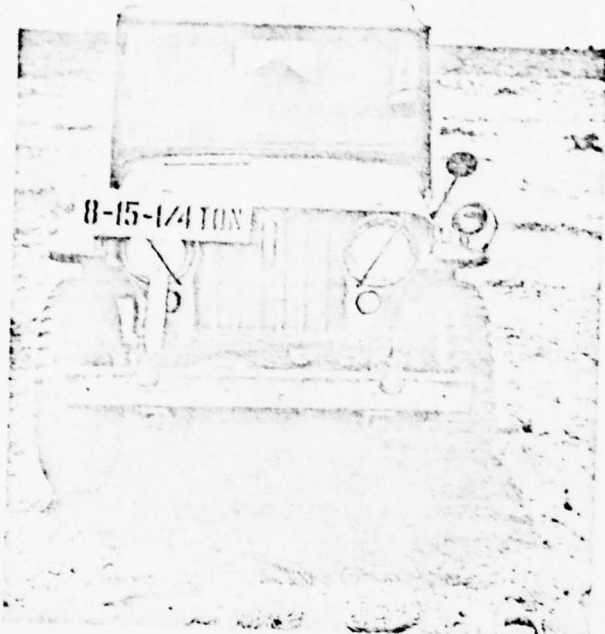
BEFORE

Truck,  $\frac{1}{4}$  ton 4 x 4, M-38  
facing GZ at 1500 yards.

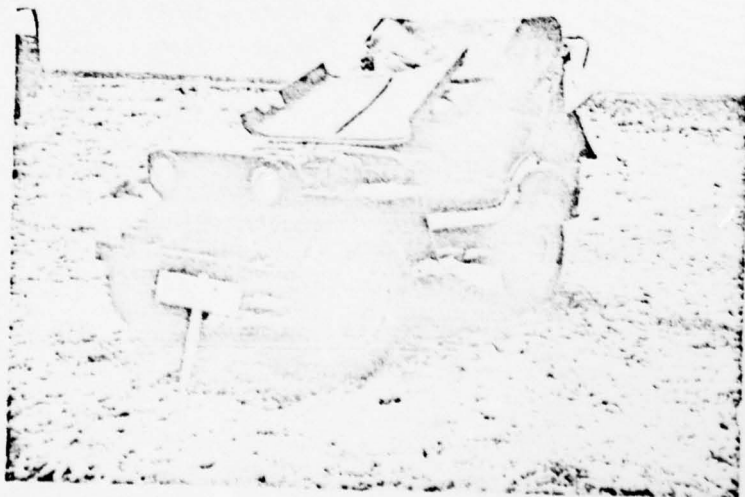
AFTER

Windshield broken and  
frame bent. Hood blown  
open and cowl bent.  
Canvas torn off.

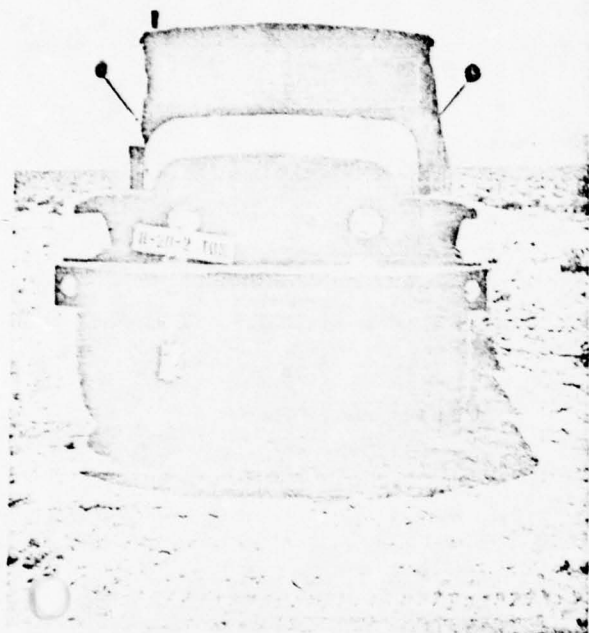
BEFORE

Truck, 2½ ton 6 x 6, M-135  
facing GZ at 2000 yards.

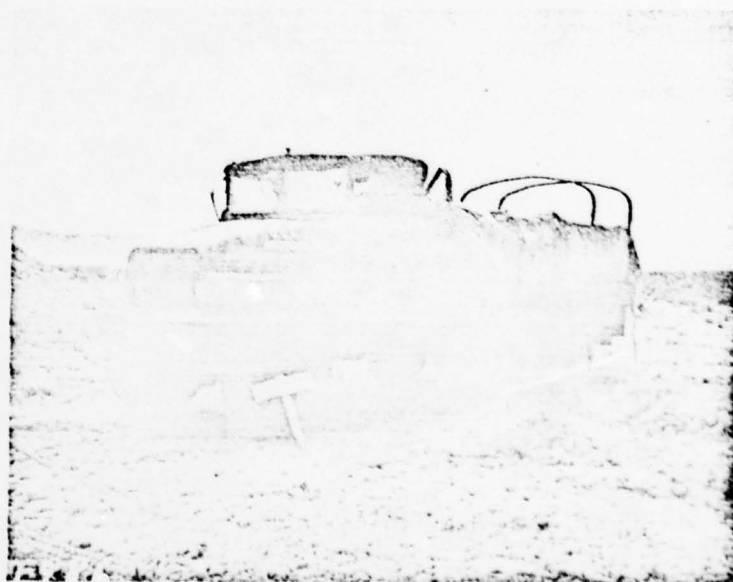
AFTER

All glass shattered.  
Canvas torn and burned.

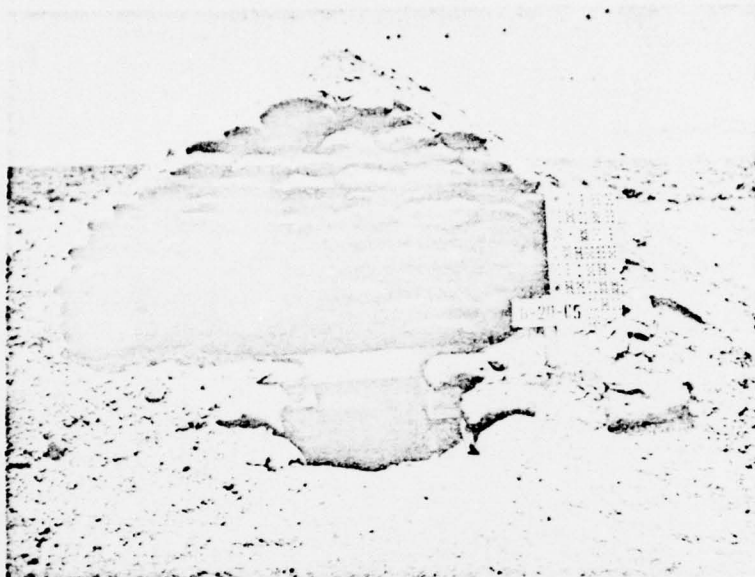
**BEFORE**

C-5 bunker 2000 yards  
south and slightly  
east of GZ with en-  
trance facing north.

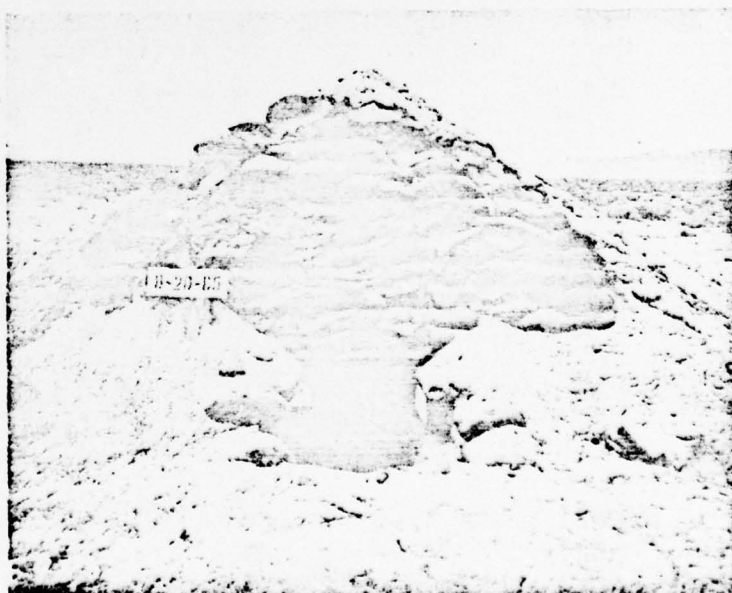
**AFTER**

Front layer of sandbags  
burned and broken. Sand-  
bag fill fell into entr-  
ance.

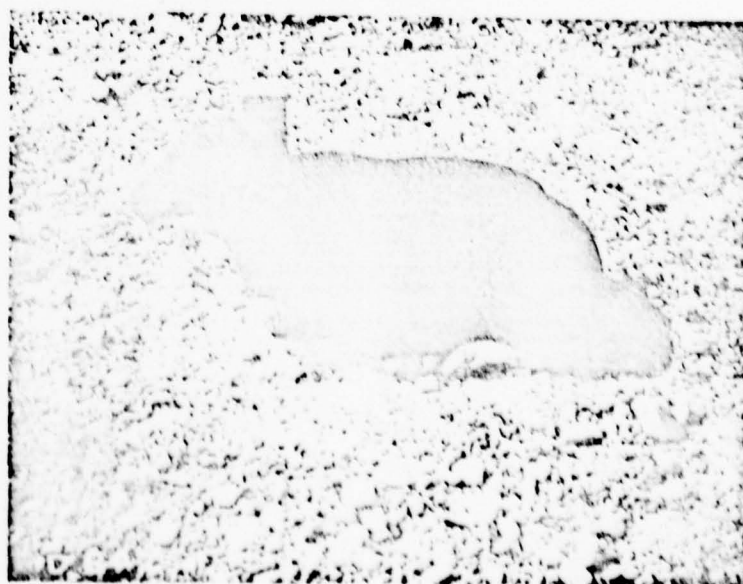
C-9 1000 yards. This animal suffered 3rd degree burns on the face and extensive wool burns on the body. Inappetence diarrhea, and in-coordination developed on 9 May followed by death on 10 May from acute radiation sickness.

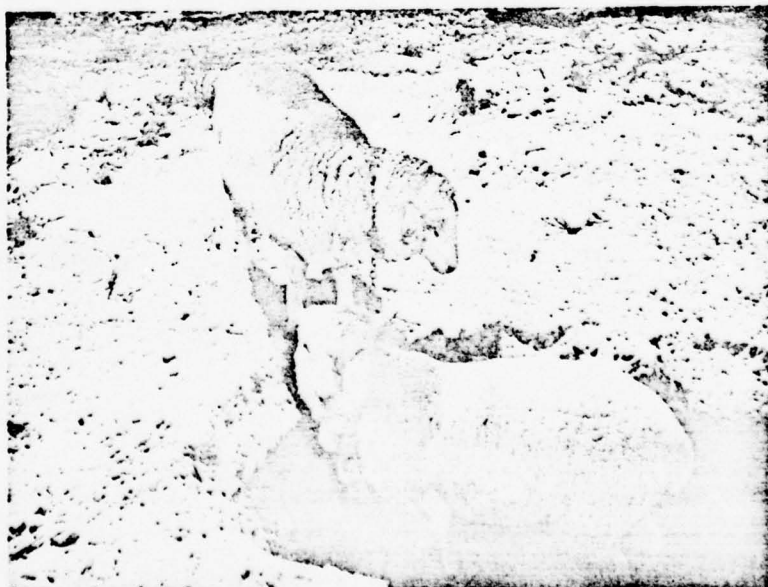
C-1 & C-2 2000 yards. Both animals show 2nd degree burns on the face and ears with moderate burns on the back. They will apparently recover from the effects of the detonation.

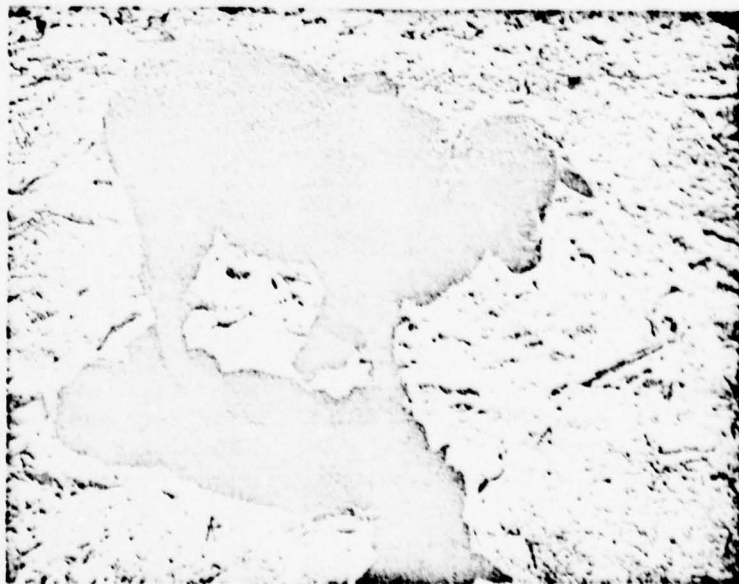
C-1 1500 yards. This sheep received 3rd degree burns on the face and ears and extensive wool burns over the back. This animal developed symptoms of radiation sickness on 12 May.

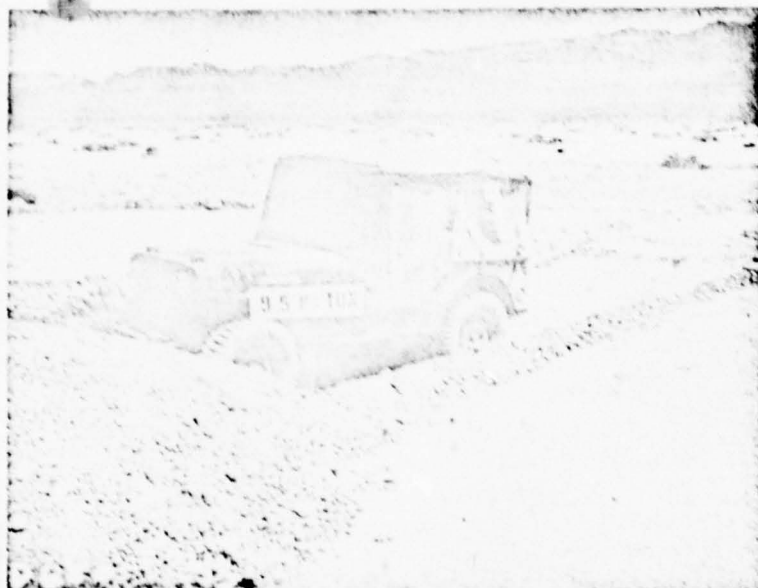
BEFORE

Truck, 1/4 ton 4 x 4,  
M-38, 500 yards from  
GZ. Vehicle is facing  
GZ and placed in a 2  
foot hole.

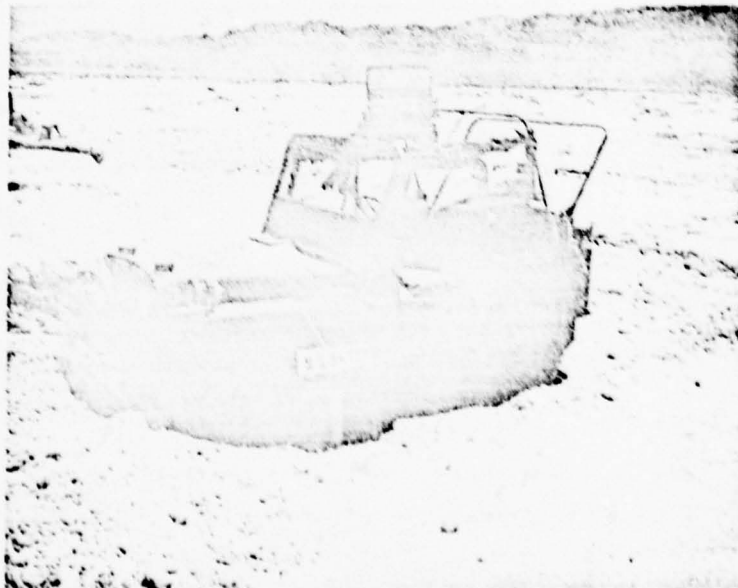
AFTER

Top burned off. Hood  
and cowl bent. Wind-  
shield blown out. Right  
hand seat and paint on  
side burned.

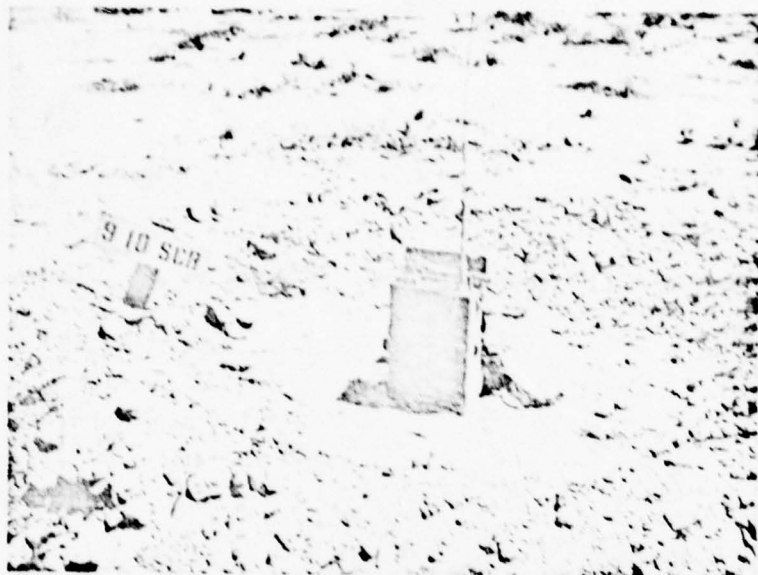
BEFORE

Radio, SCR-300,  
standing upright  
1000 yards from  
GZ.

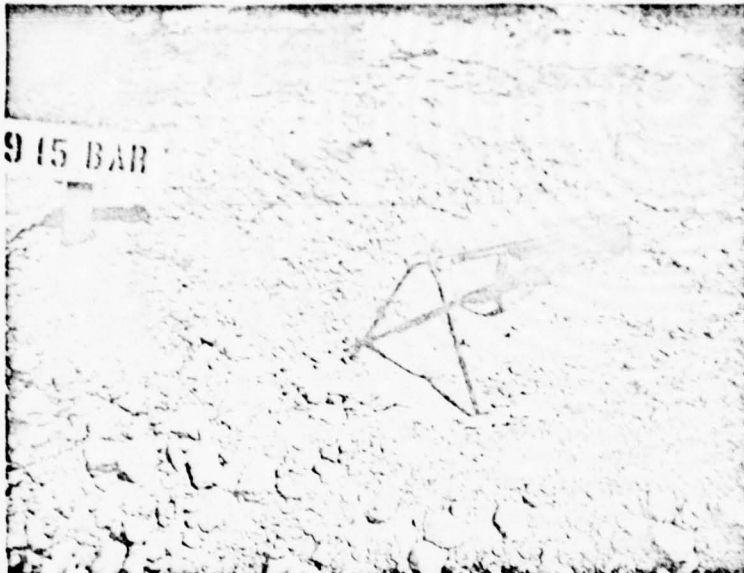
BEFORE

Rifle, Browning  
Automatic, Cal. 30,  
M1918A2, facing CZ  
at 1500 yards.

Not damaged. Turned  
on side.

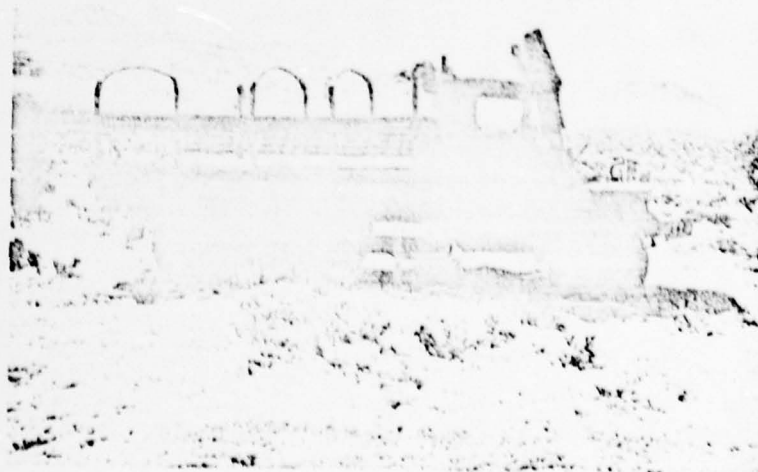
AFTER

Hood opened and bent.  
Paint and seats on  
right side burned.  
Right door bent and  
glass shattered. Left  
door glass broken. Can-  
vas body top blown 25  
feet to rear.

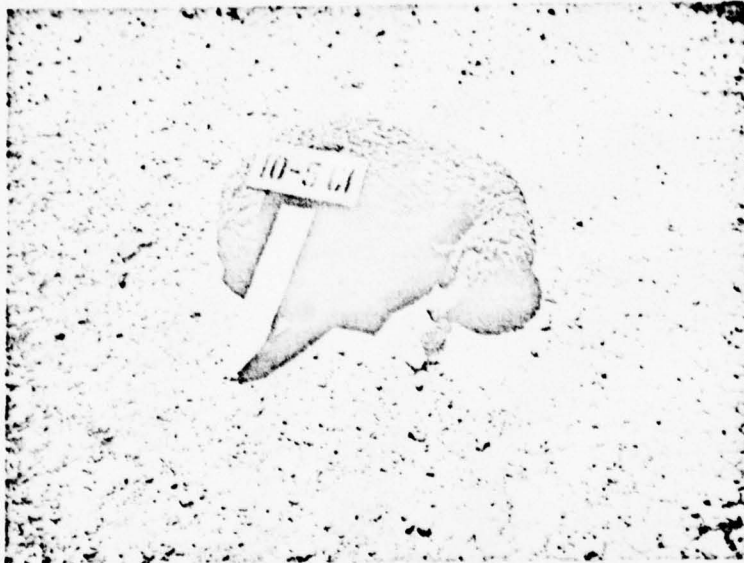
C-1 at 500 yards. This animal was not found after the detonation but was found two days later 500 yards from the original position. The sheep was burned extensively and killed by the effects of the blast. Dosimeter reading lost.
